Sailors and Marines reducing mishaps **BRAVGO** *Zulu*

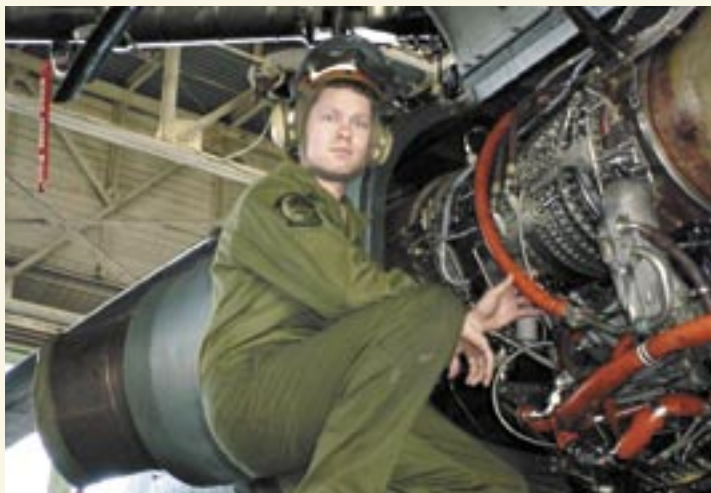
Airman Michael Luebke
HM-14

While doing a daily inspection on an MH-53E, Airman Luebke noticed the alignment of the No. 1 engine's center-isolation mount was off-center. Further inspection revealed metal-to-metal contact between the engine-isolation mount and the quick-engine-change (QEC) frame. He immediately notified maintenance control and QA.

During QA's investigation, it was discovered the engine's torque-shaft housing was misaligned by one bolt, causing the engine mount to be off-center. Airman Luebke's strict attention to detail prevented a possible catastrophic failure of the QEC frame, resulting from undue stress caused by the misalignment.

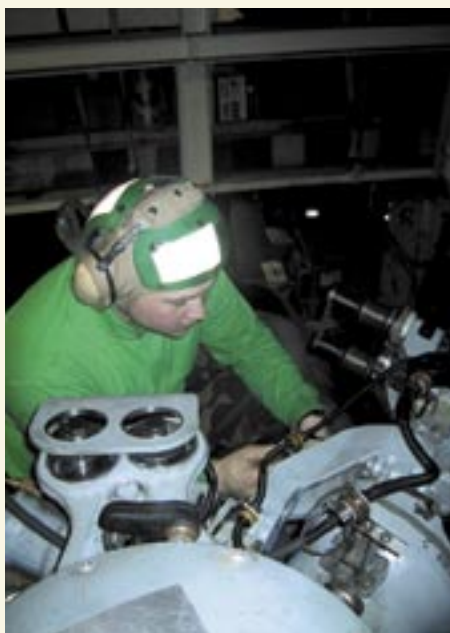
AEAN Michael Reimann
HSL-46 Det 4

While Cutlass 467 was turning on deck, awaiting an amber deck to remove chocks and chains to launch on a C-Profile FCF, AEAN Reimann noticed a small piece of FOD come off the right side of the helicopter. He immediately signaled the LSE for entry into the rotor arc and retrieved the FOD from underneath the aircraft. He took the FOD (a small piece of rubber from the black, main, rotor-blade bumper) to the maintenance shop to ensure 467 still was safe for flight. AEAN Reimann's quick action and keen attention to detail ensured Cutlass 467 completed its FCF safely and that the FOD didn't cause a hazard to the aircraft, personnel on deck, or to the ship's RSD.

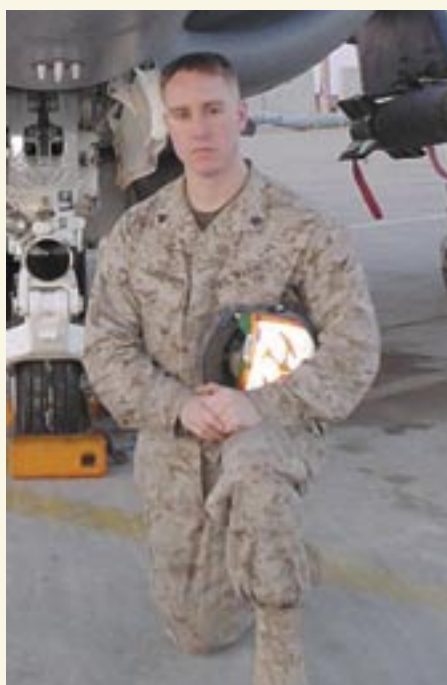
Sgt. Flaten
VMA-311 "Tomcats" (currently deployed to Al Asad Iraq)

Sergeant Flaten showed extreme attention to detail on the night of March 2, 2005, when he discovered a parachute-riser assembly for the ejection seat was installed wrong. Had this equipment been installed in an aircraft, the aircrew easily could have been led into thinking the improperly installed koch fitting and SEAWARS just were twisted. Had an aircrewman attached the riser to his torso harness, he would have put an unintentional twist into his parachute riser. This action could have resulted in serious injury to aircrew in the event of an ejection.

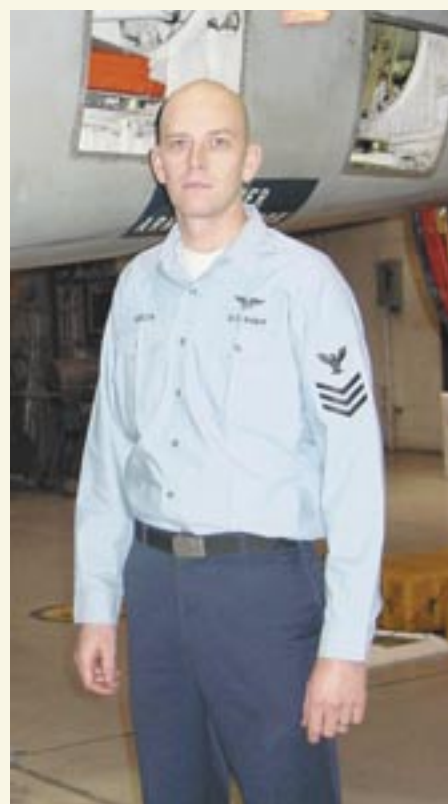
AM1(AW) Gary Garstin
VAQ-139

Petty Officer Garstin was troubleshooting a popped flap/slat circuit breaker when he noticed substantial grease build-up around the gearbox of a squadron EA-6B. A flaperon cable also was chafing against an adjacent hydraulic line. Upon further investigation, it was determined that all but two strands of the cable were severed, and the hydraulic line nearly was sawed in half.

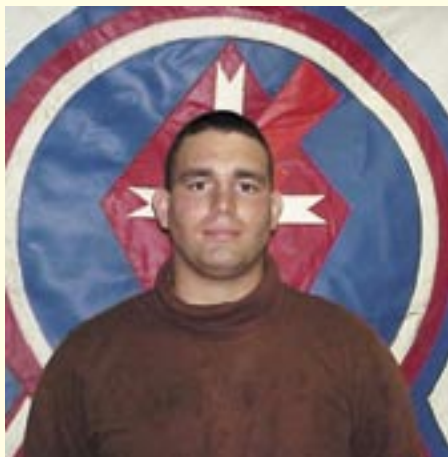
**Sgt. Wiggins
VMFA-251**

Sgt. Wiggins felt a very small "rough" spot on the back of one of the stators in the 7:30 position. He notified Maintenance Control and Quality Assurance.

An investigation revealed that a bushing had worn and seized, causing the joint between the inlet variable guide vane and the stator to become prematurely fatigued, which resulted in structural failure of the component. Had this gone unchecked for much longer, it would have certainly resulted in the IGV breaking off and being sucked into the compressor section.

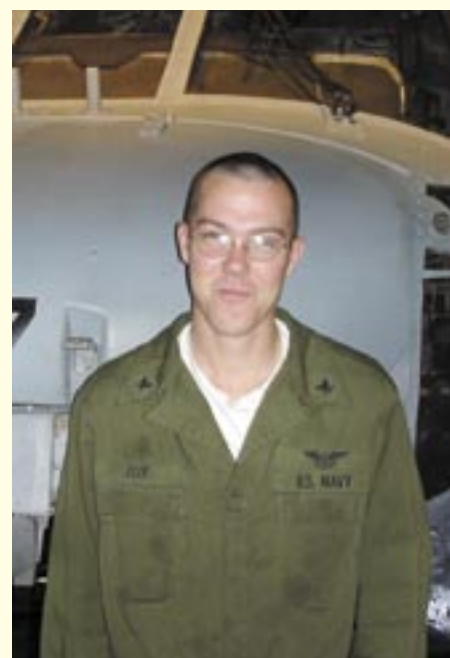
**AD3 Brandon Joy
HSL-44 Det 1**

During a daily inspection, Petty Officer Joy found fuel leaking from the pressure-refueling panel on Magnum 447. He quickly investigated the problem and isolated the leak to the pressure gauge. AD3 Joy directed the defueling of the aircraft and made a more in-depth inspection. He noticed the gauge body was loose, tightened and reinstalled it, then refueled the aircraft with no further problems.

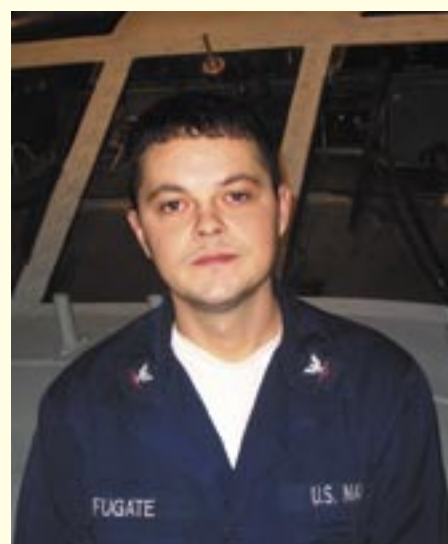
AM3 Aaron Fugate
HSL-44 Det 1

During a 56-day special inspection on Magnum 447, Petty Officer Fugate noticed what appeared to be a crack in the sealant on a main-rotor tip-cap. Investigating further, he carefully removed the sealant and found that the tip-cap was cracked and needed replacement.

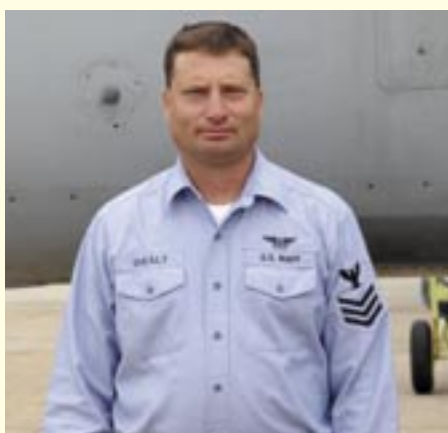
AD1(AW) Michael Shealy
VFA-87

While serving as the line division LPO Oct. 4, 2004, Petty Officer Shealy distinguished himself through exemplary performance and unwavering dedication to duty. During flight operations at NAS Oceana, in support of unit-level training, he noticed

a drill bit laying on the ground in the fire lane of the War Party flight line. He then searched the immediate vicinity and found four more drill bits on the ground. He immediately notified maintenance control, and flight operations temporarily were suspended while a combat FOD walkdown was held. A quick assessment revealed the source of the hard FOD was a flight-line vendor. The wing was notified, and squadrons at NAS Oceana were alerted to the potential FOD hazard that existed on their flight lines. His quick and decisive actions and attention to detail averted potential damage to the War Party aircraft. If left unnoticed, the drill bits could have caused catastrophic damage, costing thousands of dollars and lost sorties. His acute attention to detail during high-tempo and high-visibility flight operations highlights his commitment to excellence through professionalism and safety.
